Manhole Inspection Summary

Manhole # S02GG2002MH

Location Address: **3209 FALLSTAFF RD**

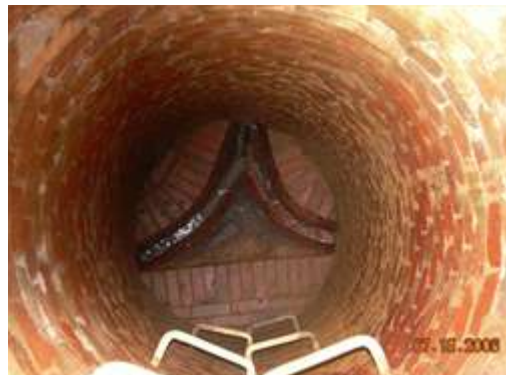
Top View

Corbel and Barrel infiltration.

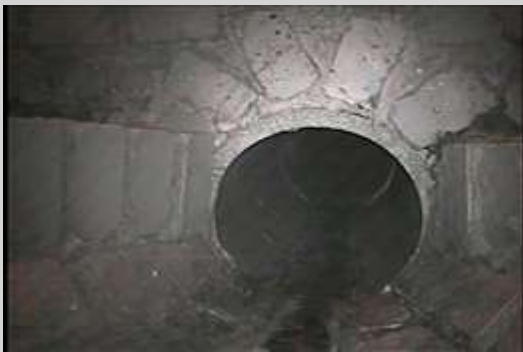
8 in. Circular Gravity Sewer Pipe Out @ 12 O'Clock

Comments **The O12 pipe picture shows Channel deterioration.**

Condition: ☐ Sound ☐ Cracked ☐ Root Intrusion ☒ **Deteriorated** ☐ Leaks ☐ Debris

Infiltration: **Evidence** Pipe Seal Cond: **Cracked**

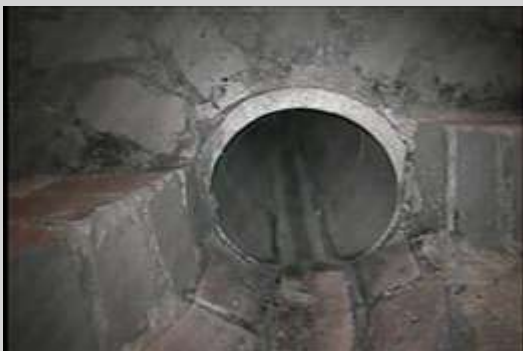
8 in. Circular Gravity Sewer Pipe In @ 3 O'Clock

Infiltration: **Evidence** Pipe Seal Cond: **Roots**
